# **Prioritising Springs of Ecological significance in the Flinders Ranges**

**Melissa White and Glen Scholz**

**Knowledge and Information Division  
Department of Water, Land and Biodiversity Conservation**

**Report DWLBC 2008/XX Version 1**

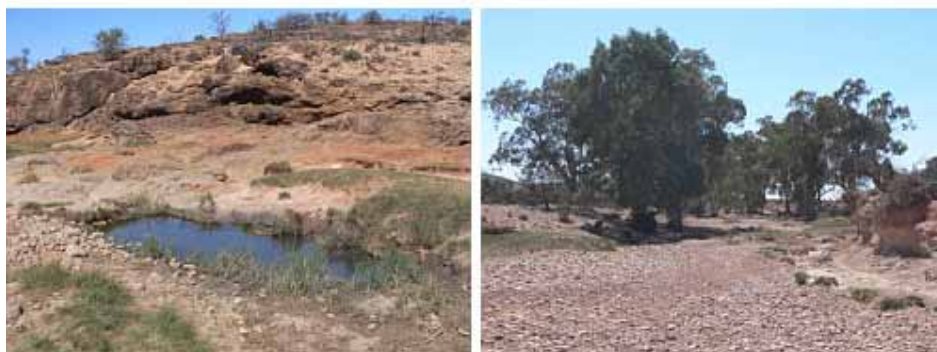
**Figure 1.1 Example of a permanent pool located in a temporary stream on Puttapa Station (photograph M.White, 2008).**

A diverse array of aquatic ecosystems exist in the Flinders Ranges and include: permanent and temporary freshwater pools and (Figure 1.1); salt lakes; and springs (Boulton and Williams, 1996). There are no large natural freshwater lakes in the ranges. Most natural standing freshwater is found within ephemeral pools in deflation basins on the plains (claypans) and rock pools in the ranges, that seldom persist for more than a few weeks (Boulton and Williams, 1996). This project will focus on the spring aquatic ecosystems in the Flinders Ranges, which provide the most reliable source of surface water.

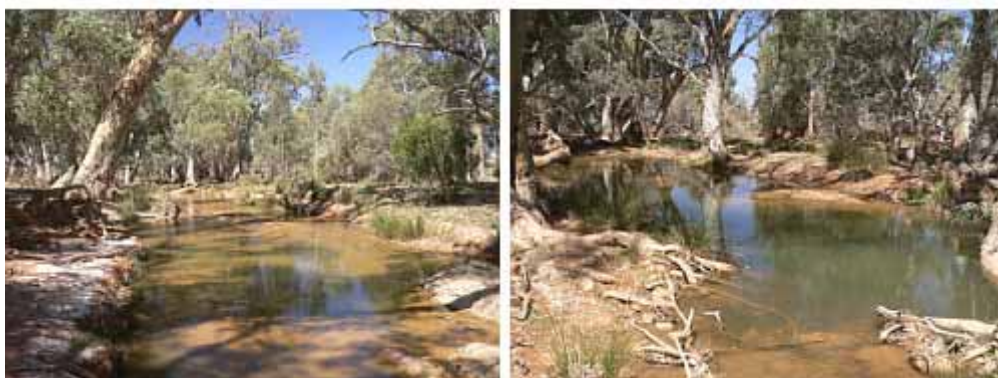
**Figure 1.3 Yadnapunda Spring on Willow Creek Station, an example of an aesthetically pleasing spring environment that attracts tourists (photograph M.White, 2008).**

Benefits of excluding stock from natural watering areas include reduced sediments, reduced pugging, less edge damage, less grazing impact, improved seeding of desirable plant species, less mud-induced mastitis and easier stock management (Ehmann, 2005). Watering points in good condition are a significant asset to a property and in the Flinders Ranges where many stations are opening their gates to tourists, the extra benefit of fencing off springs is the creation of a place that tourists like to visit (Figure 1.3).

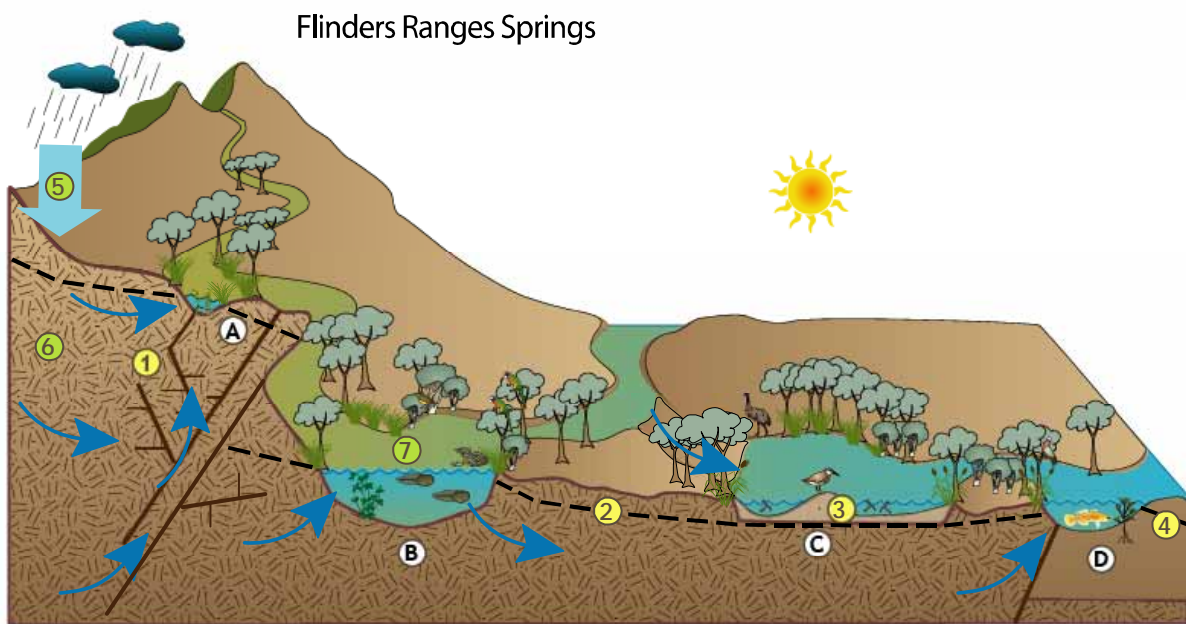
### Spring types

- (A) Fractured Rock      (B) Groundwater Discharge      (C) Sub-surface Flow      (D) Fault Line

- A - Fractured Rock: water follows rock fractures, which may lead to the surface. These fracture features often mimic rainfall events.  
 B - Groundwater Discharge: where groundwater from an underlying aquifer is expressed at the surface, these are usually permanent features.  
 C - Sub-surface Flow: whereby a stream disappears underground and is expressed at the surface when the sediment type is very porous.  
 D - Fault Line: when groundwater travels along a fault line and intersects a streambed and water be expressed at the surface.

- A. Fractured Rock: water follows rock fractures, which may lead to the surface. These fracture features flow after rainfall events.
- B. Groundwater Discharge: where groundwater from a deeper aquifer is expressed at the surface; these are usually permanent features.
- C. Sub-surface Flow: whereby a stream disappears underground and is expressed at the surface; these may also be permanent features.
- D. Fault-line: when groundwater travels along a fault line and intersects a streambed and water is expressed at the surface

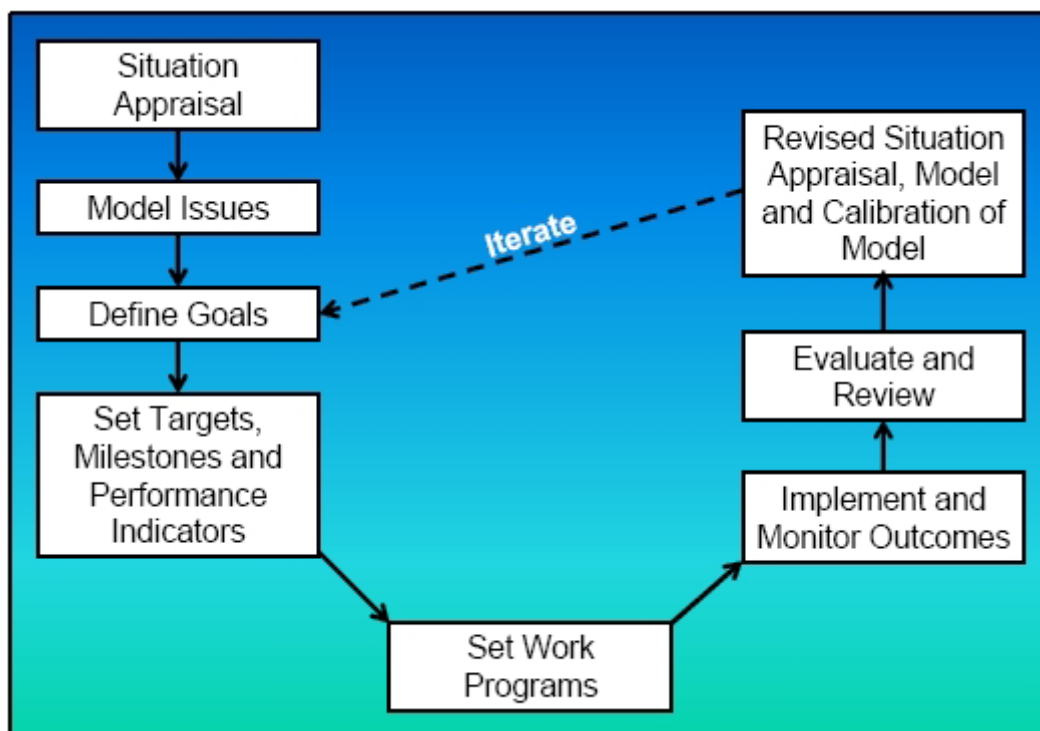
**Figure. 3.1 The project planning cycle, DEH 2007 (unpublished).**

The management of natural resources requires a clear and complete planning and evaluation process to achieve successful investment and management outcomes. Many natural resource management programs are based on incomplete planning processes where they are initiated at the “Setting Targets” stage and go straight to the “implement and monitor” stage (Figure 3.1). This project seeks to provide a firm foundation for setting work programs by addressing the “situation appraisal”, development of conceptual “models” and “defining goals” through a prioritisation process.

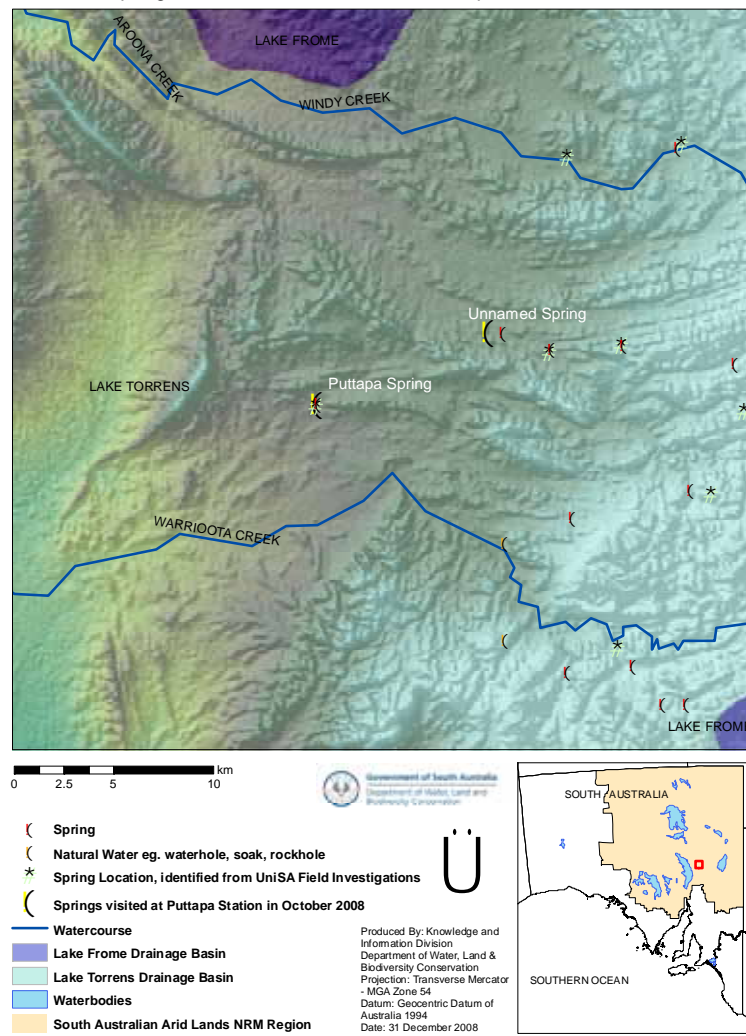
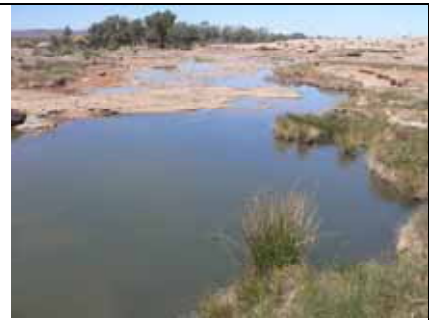
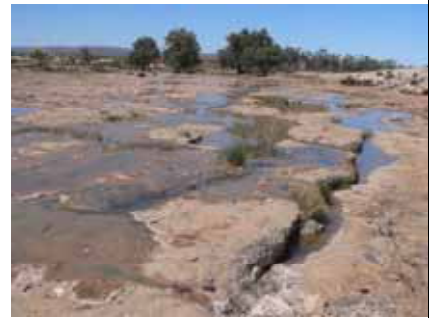
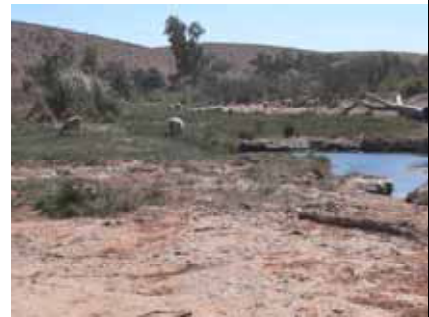
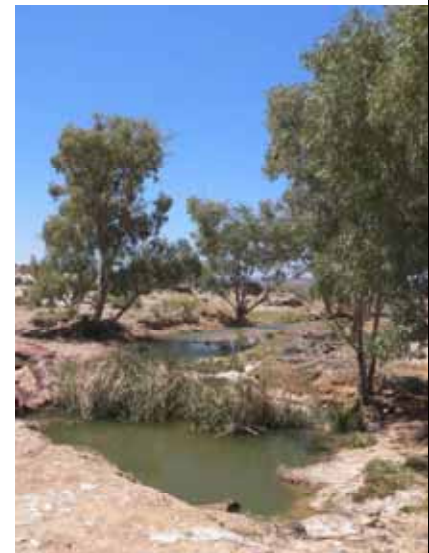
These pools are part of the Puttapa Spring system.  
Photos taken in October 2008 by Mel White.

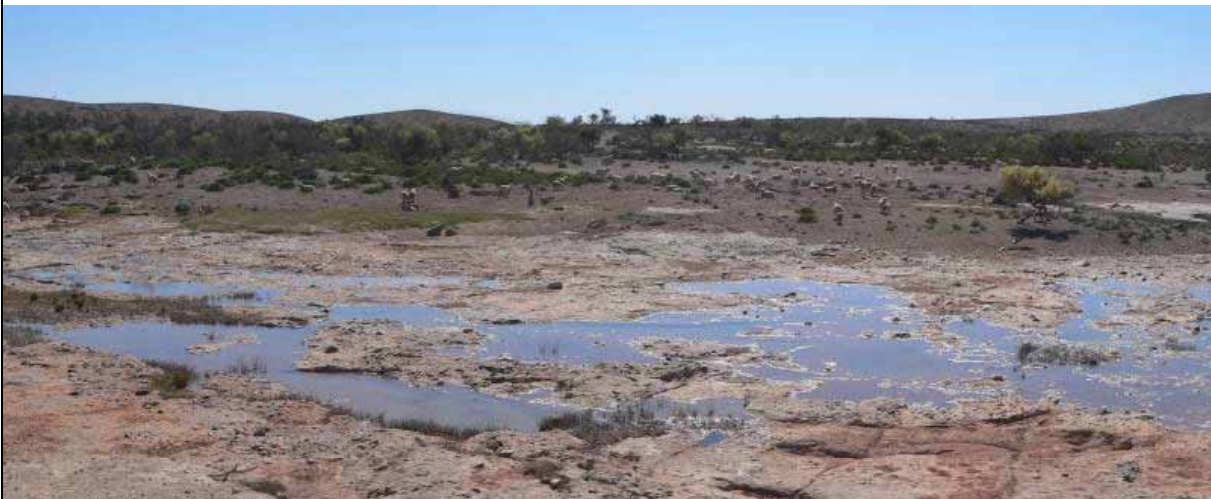
Photograph of the shallow pool section of Puttapa Spring, with stock seen on the banks. Being a shallow crossing that is highly used by stock, little vegetation exists along the spring edge in this section. October 2008 (Mel White).

**HIGH:** Based on the springs HIGH restoration potential, its hydrological permanence in being a key aquatic refuge for the sub-catchment, and it being a unique large wetland feature.

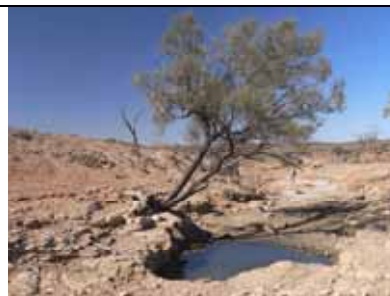
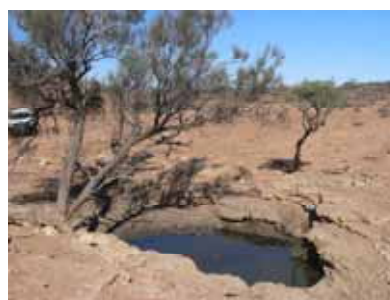
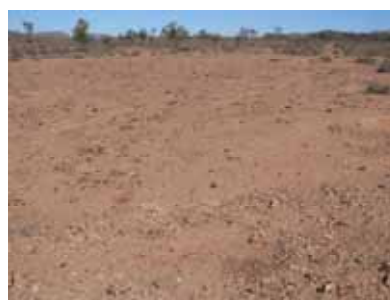
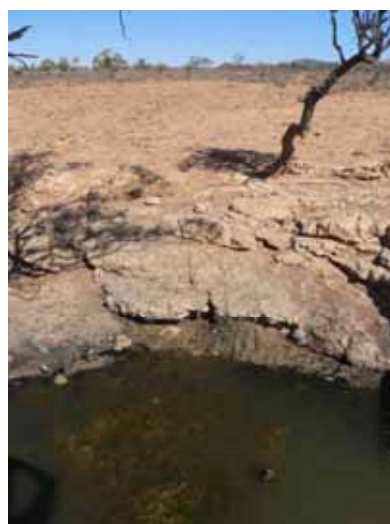
Photographs of the single pool (unnamed, while trying to find Fountain Spring).  
 Photos taken in October 2008 by Mel White.

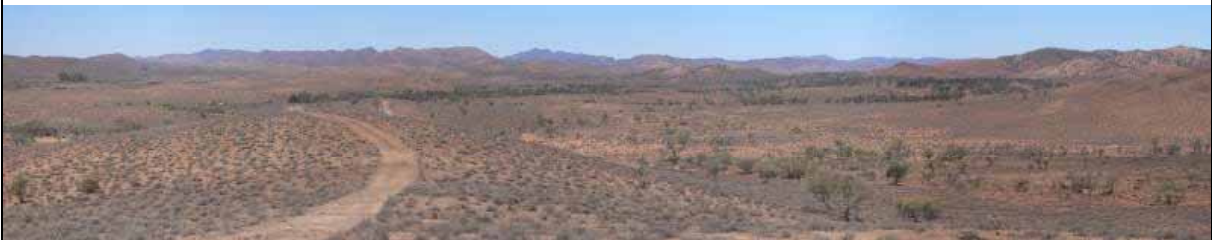
Photograph of the range where the unnamed/unmapped spring exists. The track leads to the spring which is located in a creek line at the bottom of the hill. October 2008 (Mel White).

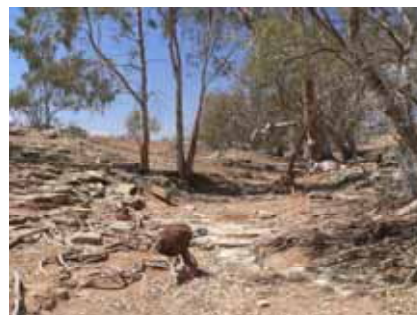
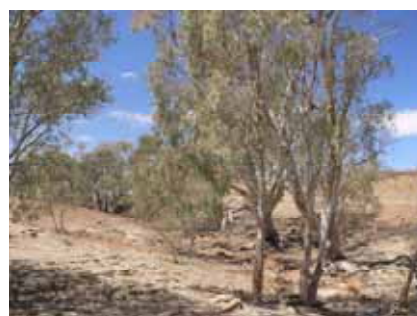
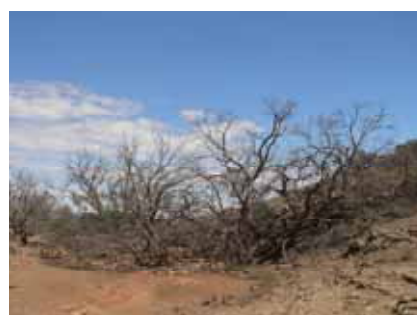
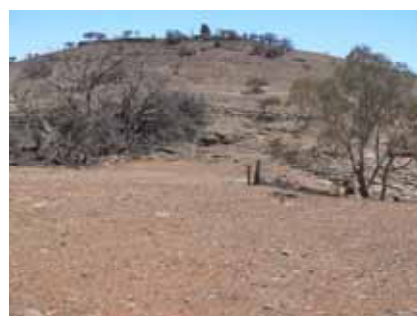
Aldoona Spring.  
Photos taken in October 2008 by  
Mel White.

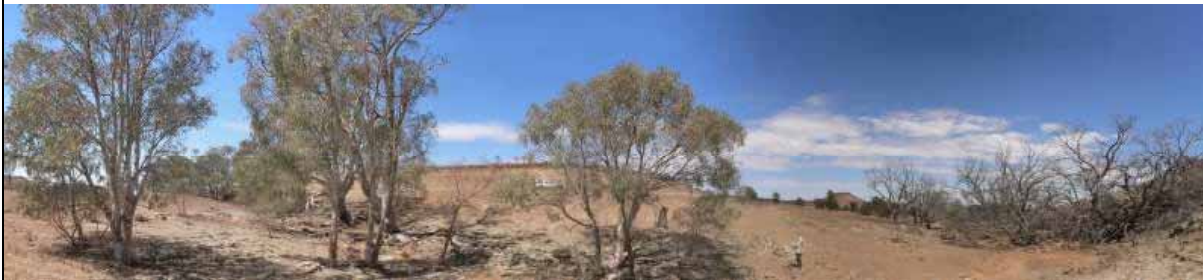
Aldoona Spring, evidence of downstream drying of spring indicated by dead red gums. October 2008 (Mel White).

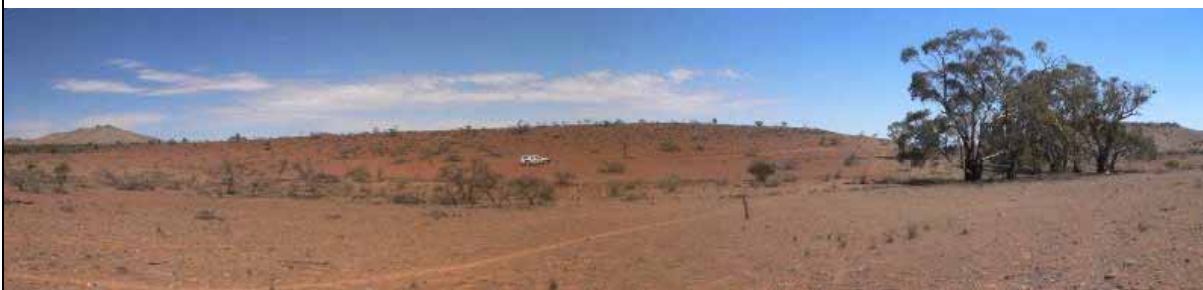
Aldoona Spring (where the red gums are on right). This photo clearly indicates the importance of the groundwater in the Flinders Ranges system, as upstream of the groundwater fed spring there are no water dependant species ie. red gums growing in the creek line. October 2008 (Mel White).

**MODERATE - LOW:** Based on the low restoration potential and its low value as a key aquatic refuge. It is advised that fenced springs be used as pilot studies for understanding the processes in designing alternative watering points and also for developing and implementing spring management plans.

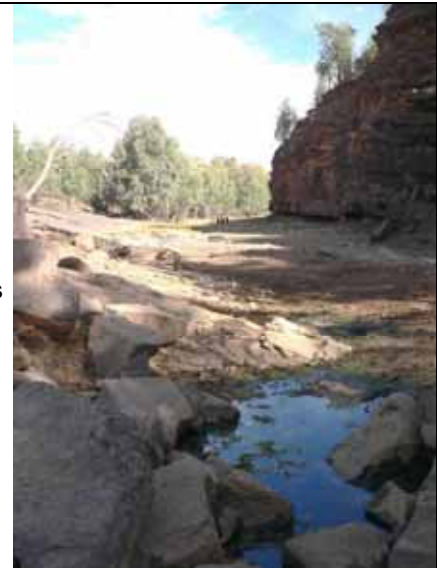
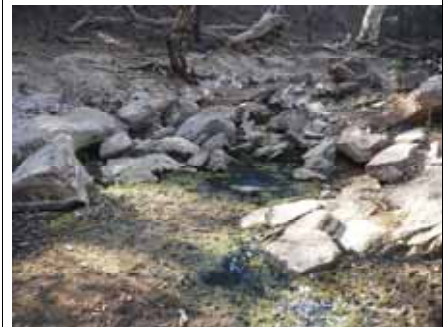
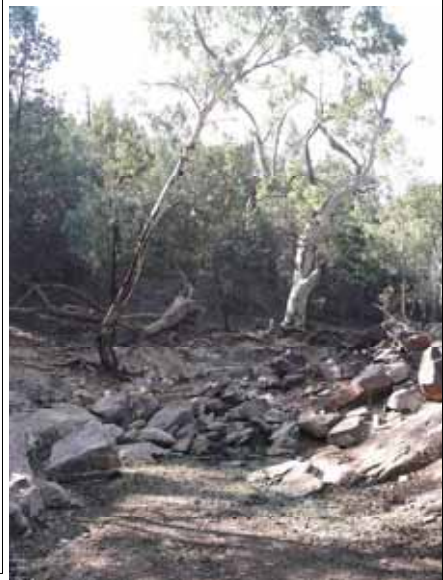
Charlies Camp Spring.  
Photos taken in October 2008 by  
Mel White.

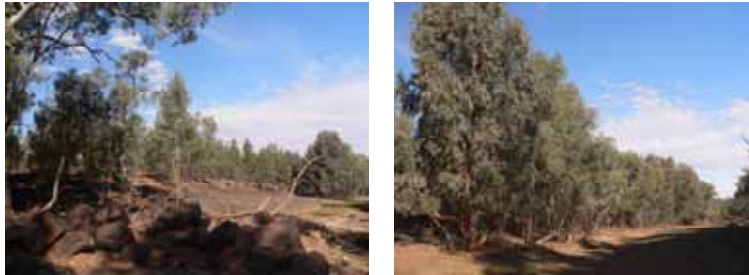
Young mature red gums downstream of Charles Camp Spring.  
October 2008 (Mel White).

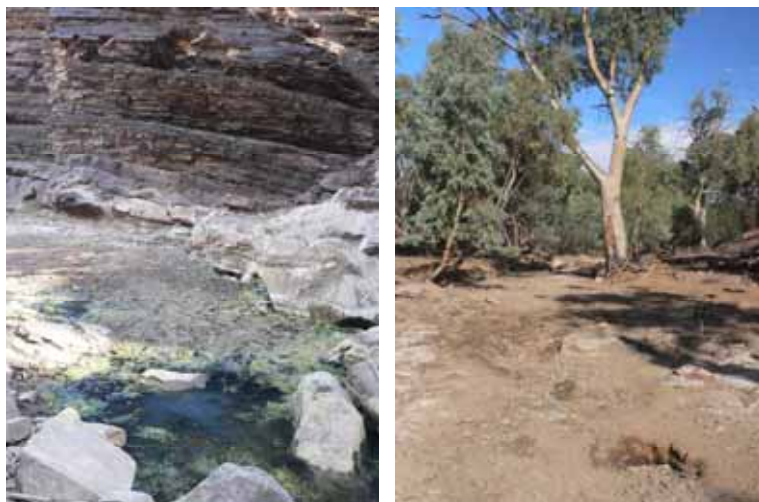
Charles Camp Spring (left) is highly used by goats, which means that the kangaroo's dig for water in the streambed (right), as the goats are territorial and will chase native animals away from water sources. Photo taken in October 2008 (Mel White).

**MODERATE:** Based on the moderate-low restoration potential. Although goat control is occurring on the property, goat management at this site is difficult due to its inaccessible location. However it should be noted that this site is adjacent to Flinders Ranges National Park and has not run stock for the last 12 years.

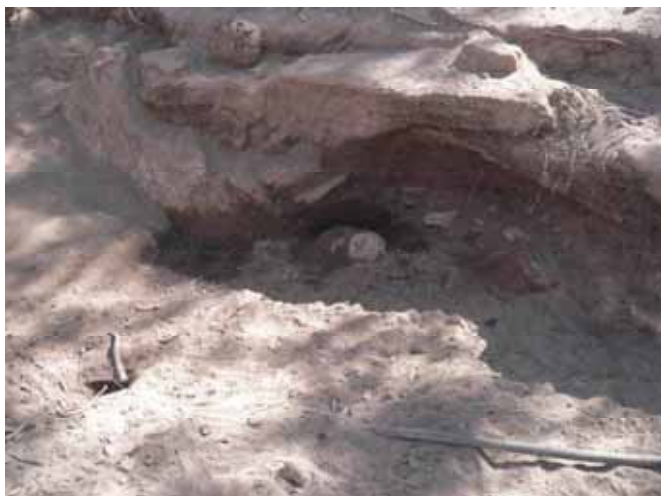
The damp soil of where Doodney's Well Spring exists.  
October 2008 (Mel White).

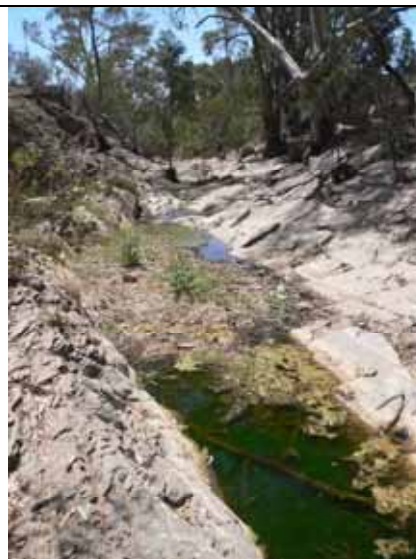
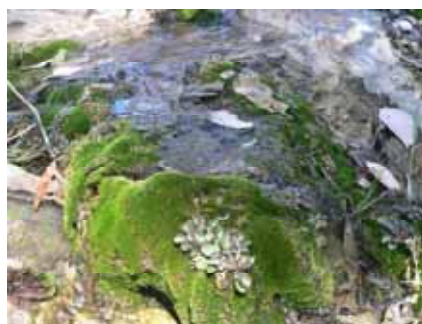
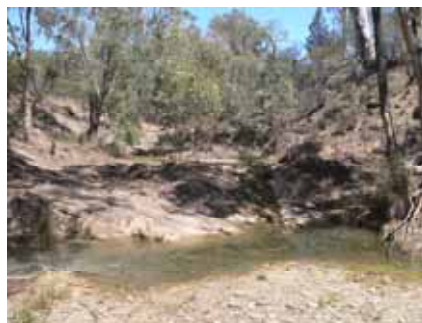
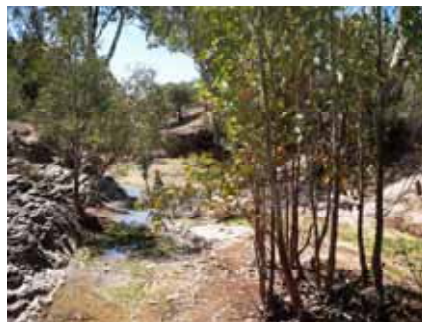
Werta Spring.  
Photos taken in October 2008 by  
Mel White.

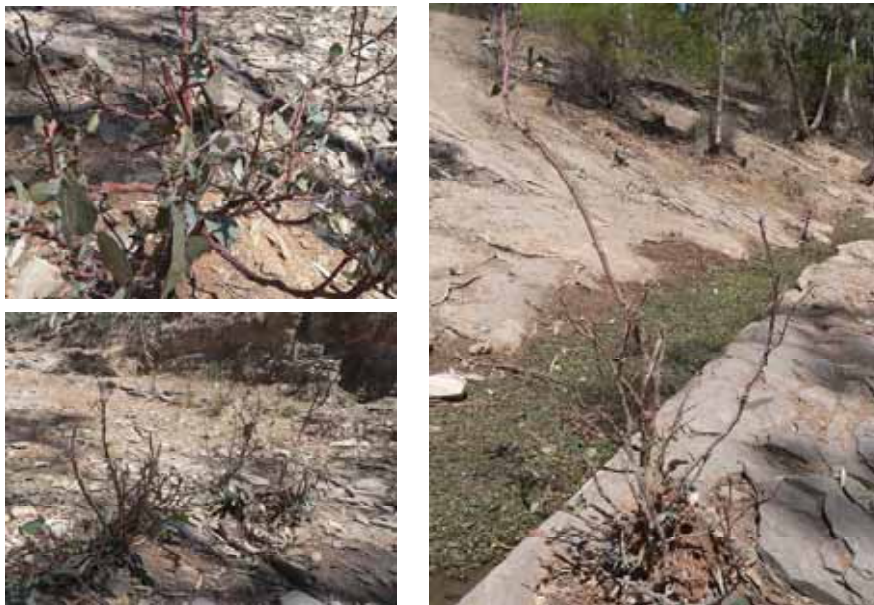
Grazing of red gum saplings at Werta Spring. October 2008 (Mel White).

**LOW:** This spring is in good condition with minimal threats noted, land management practices should be maintained.

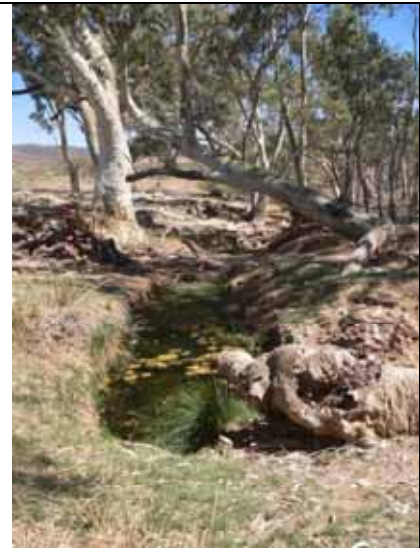
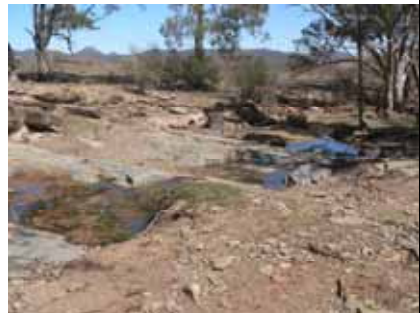
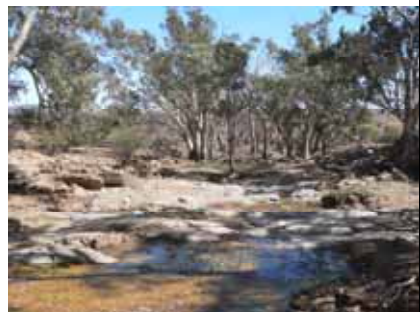
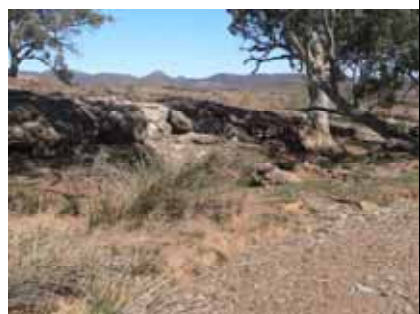
These pools are part of the 1st Spring system.  
Photos taken in October 2008 by Mel White.

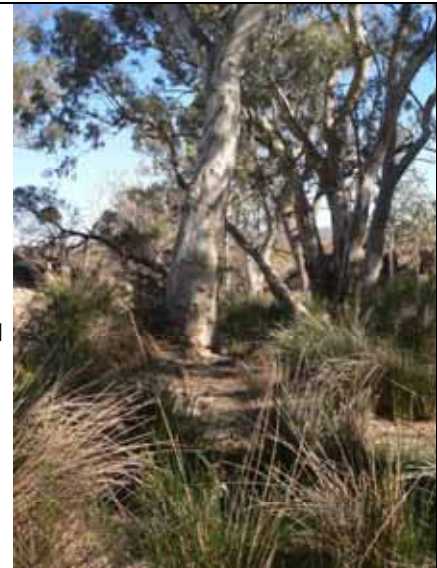
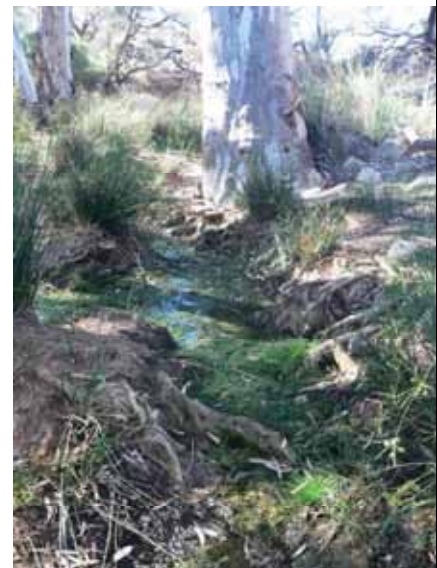
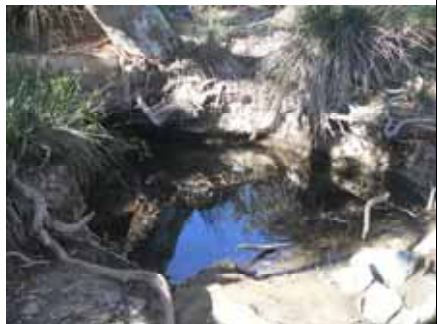
These pools are part of the 2nd Spring system.

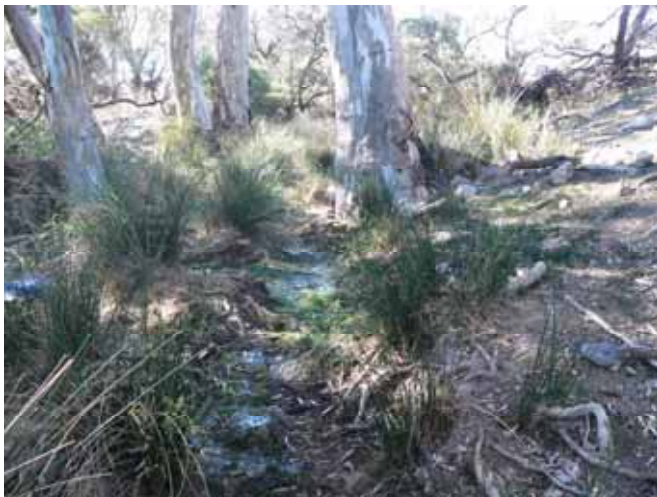
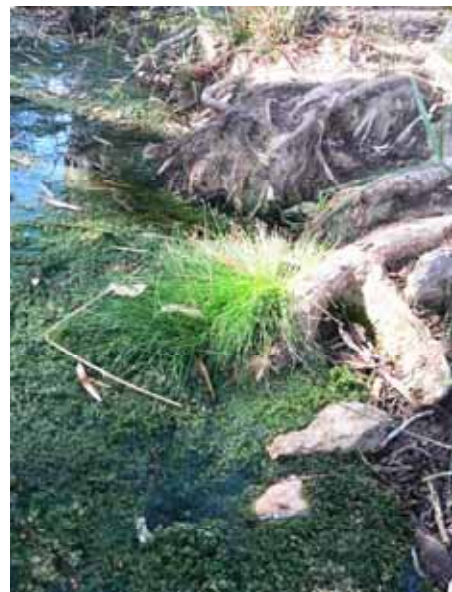
Photographs of 2nd Spring. October 2008 (Mel White).

**LOW:** Site is in good condition so current land management practices should be maintained. Site should be visited frequently after the fencing of 1<sup>st</sup> Spring has been completed to ensure that stock don't transfer grazing and drinking preference to 2<sup>nd</sup> Spring and hence degrade the site.

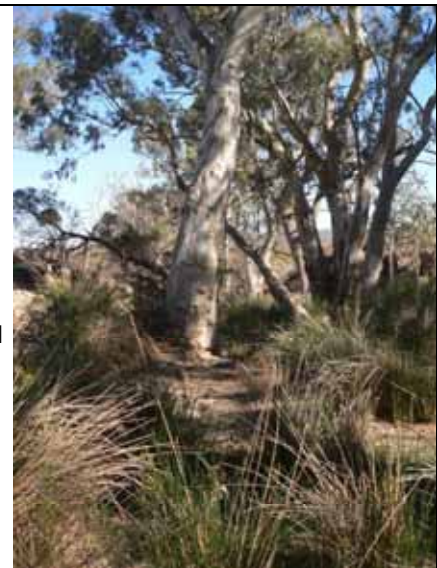
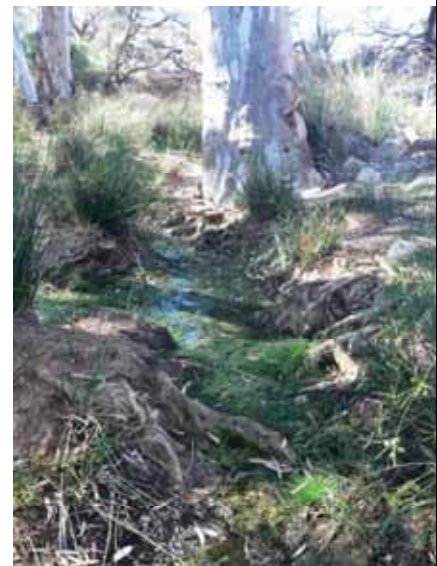
These pools are part of the 2nd Spring system.

Photos taken in October 2008 by Mel White.

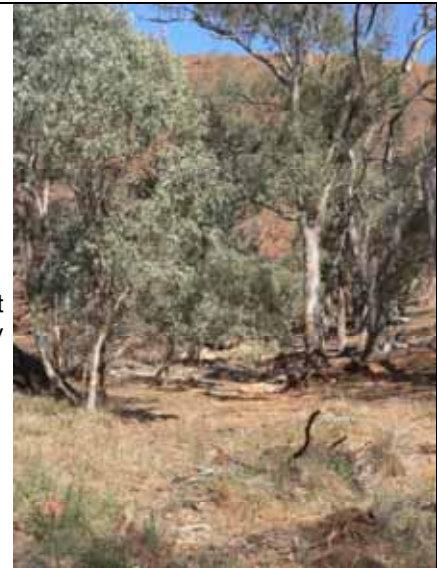
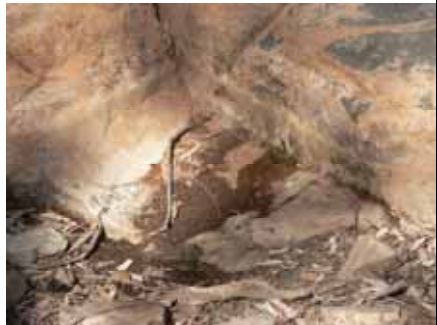
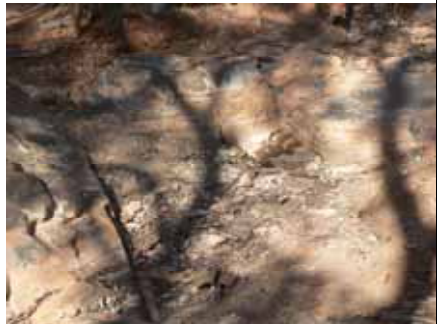
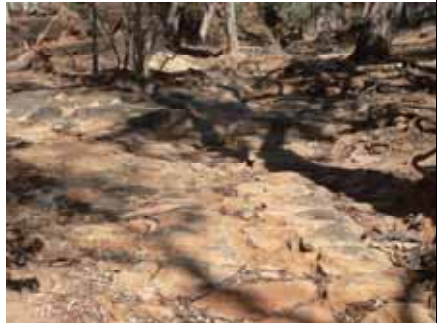
Little Spring.  
 Photos taken in October 2008 by  
 Mel White.

Indicator	Value	Description	Confidence	Management Recommendations
13	Spatial Integrity	LARGELY UNMODIFIED	There was no break in longitudinal continuity of river red gums.	QUALITATIVE	
14	Nativeness	LARGELY UNMODIFIED	Onion weed was recorded at the site.	QUALITATIVE	
15	Structural Integrity	MODERATELY MODIFIED	In the riparian zone, the shrub-cover is absent and the groundcover is greatly reduced due to long-term grazing at the site.	QUALITATIVE	Reduce grazing at spring.
16	Age Structure	MODERATELY MODIFIED	Some reduced canopy cover of red gums but not severe, only adult trees present.	QUALITATIVE	Reduce grazing so regeneration survival is increased.
17	Debris	SLIGHTLY MODIFIED	There is probably reduced debris cover due to stock trampling	QUALITATIVE	Reference condition needs to be determined

**LOW:** Till an inventory of all springs in the area is completed, it is advised that no intervention is undertaken at this spring as its value in the landscape is very similar to Reedy Creek Spring which is in better condition and is located downstream from this spring.

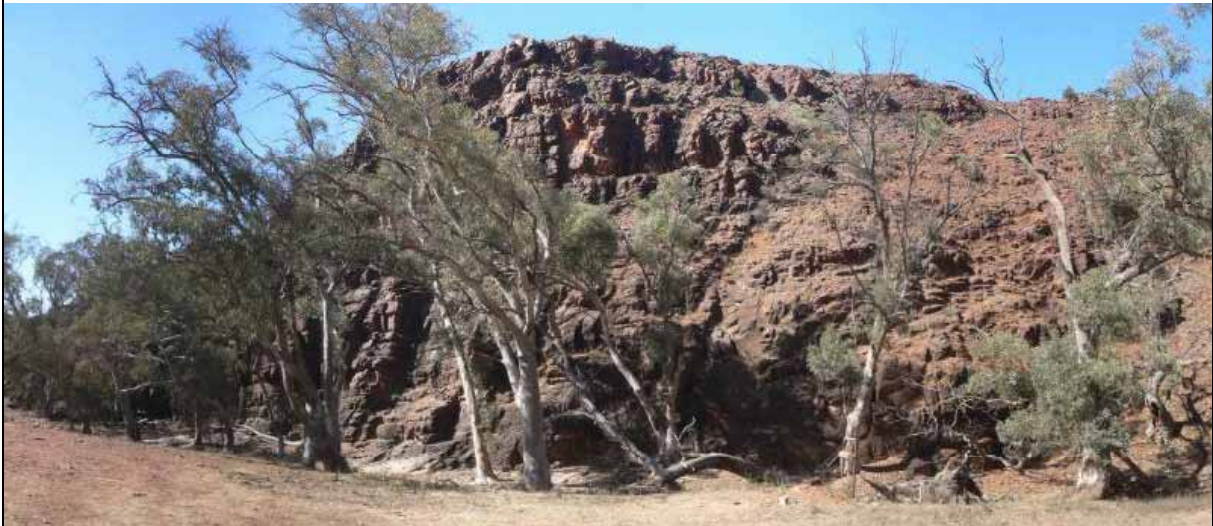
**MODERATE-LOW:** Based on the absence of the shrub strata and the modified condition of the understorey strata. The current ephemerality of spring flow and sheep grazing at the site limits vegetation restoration. It can be assumed that little vegetation response will be seen at the site until the spring flows again.

Riparian zone of the creek line where Little Spring is located. October 2008 (Mel White).

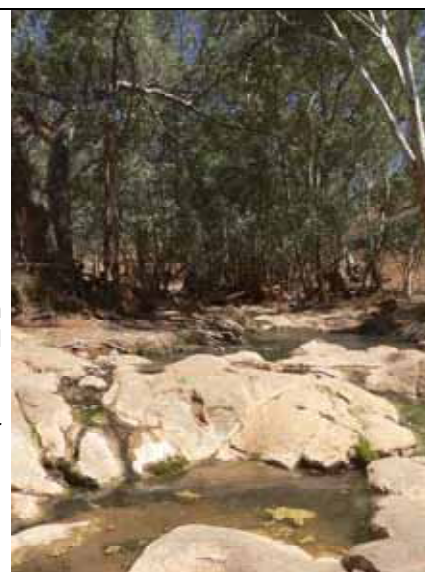
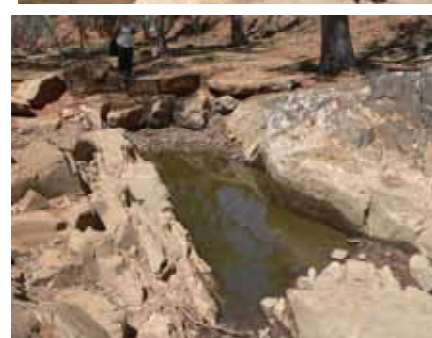
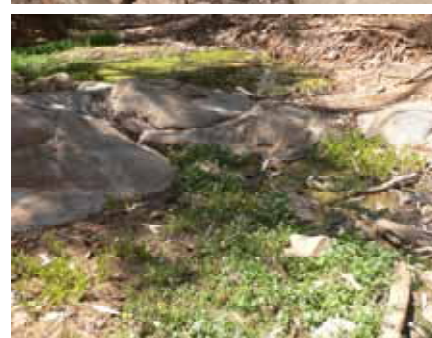
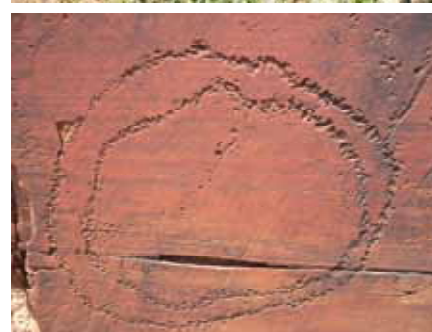
The 3<sup>rd</sup> photo from the top showing the nutrient loving aquatic plant *Rorippa nasturtium-aquaticum*. The bottom photo is of Aboriginal carvings at the site. Photos taken in October 2008 by Mel White.

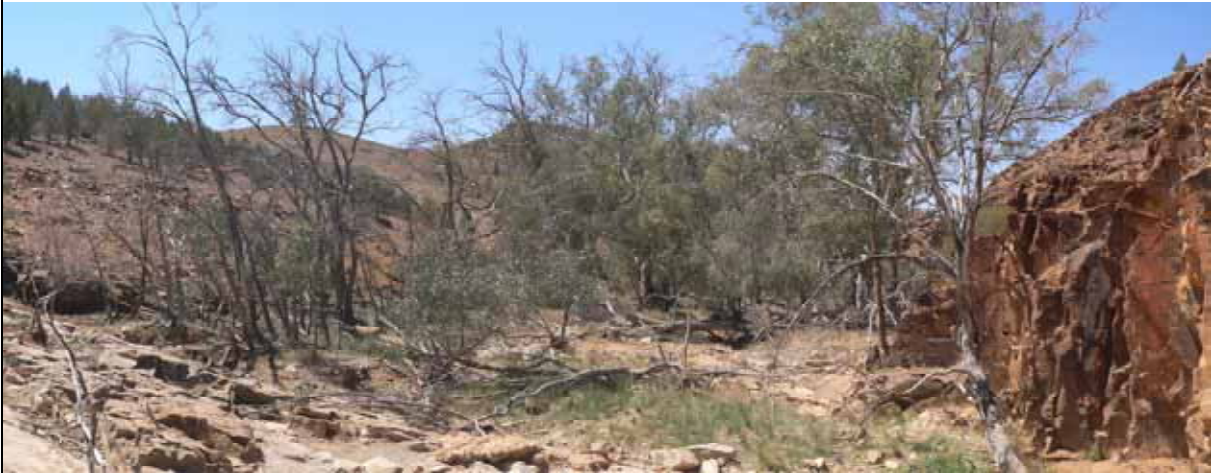
Riparian zone of the creek line downstream of Reedy Creek Spring. October 2008 (Mel White).

**MODERATE:** Based on the moderate restoration potential and its permanence as a 'key aquatic refuge' located downstream of another spring. Consultation with the Aboriginal People of the area would be advised to determine cultural importance of the site for future investments.

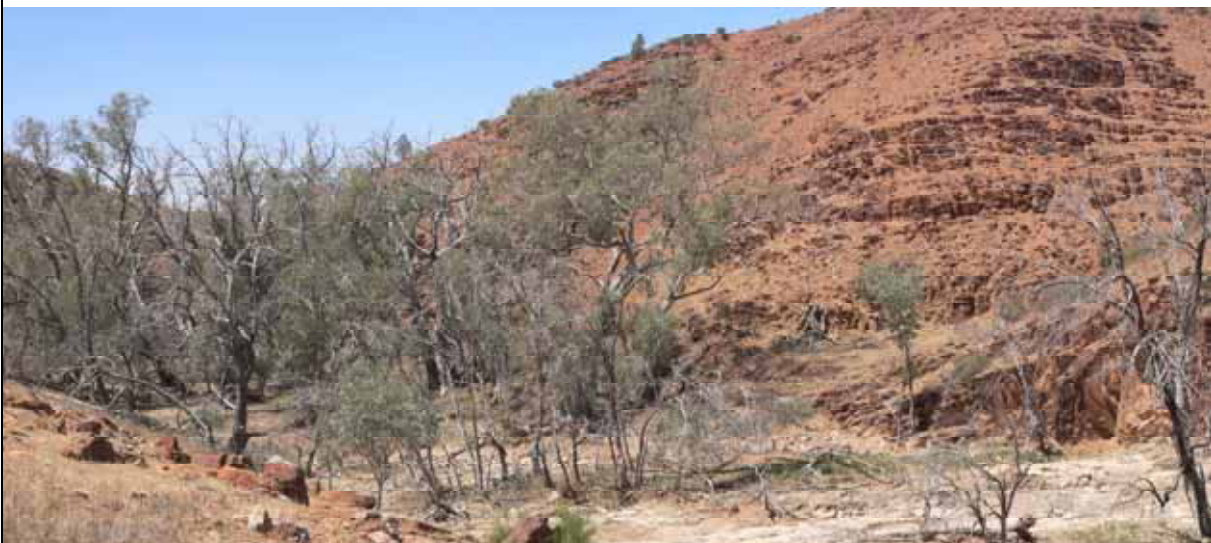
Riparian zone of the creek line downstream of where Reedy Creek Spring is located. October 2008 (Mel White).

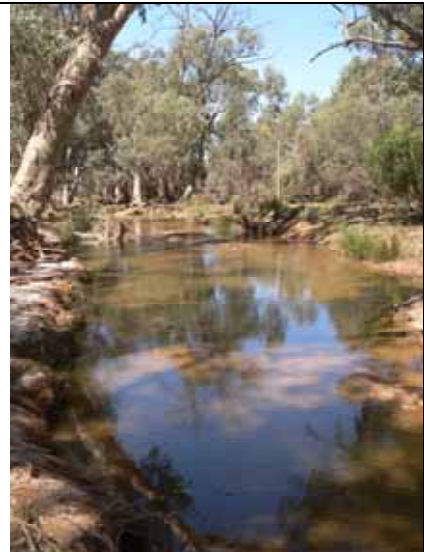
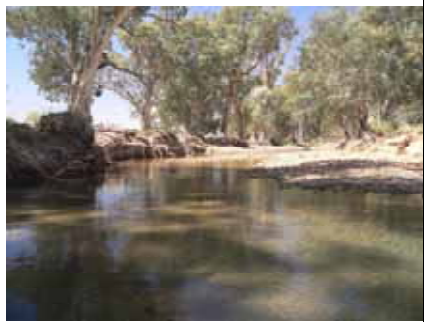
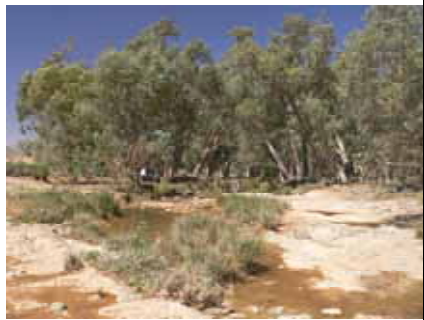
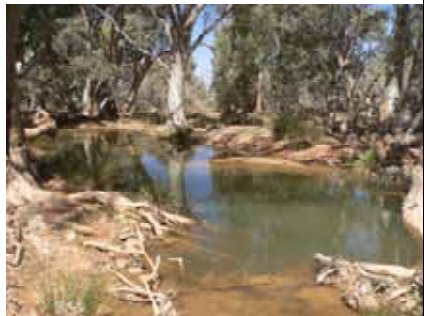
**Size:** at time of visit, the spring flowed as a series of pools for more than 600m (a fence line cuts the spring). Pool size varied, many large sized pools greater than 10 x 10 m .

**Depth:** at time of visit, varying depths from 0.2 – 1.5m

The different pools that make up the Yadnapunda Spring complex. Photos taken in October 2008 by Mel White.

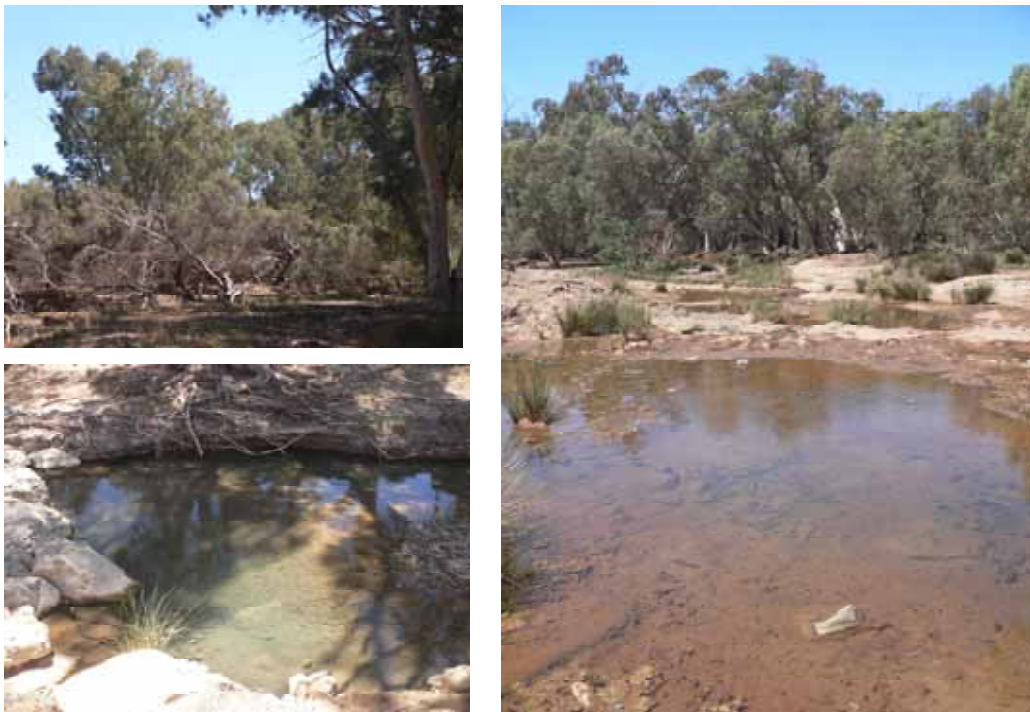
Yadnapunda Spring complex. October 2008 (Mel White).

**HIGH:** This spring has a high likelihood of being a key aquatic refuge that has a diverse array of spring habitats and riparian vegetation. It is recommended that for future assessments that a fish survey be undertaken at this site.

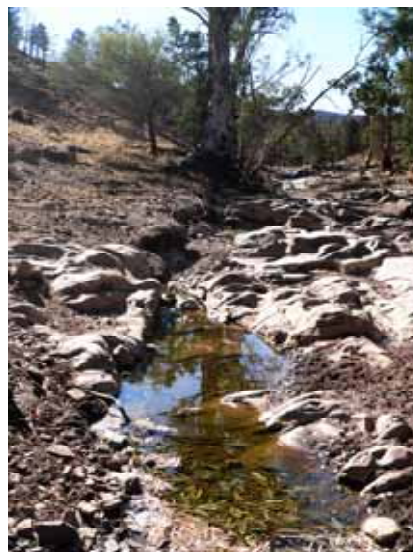
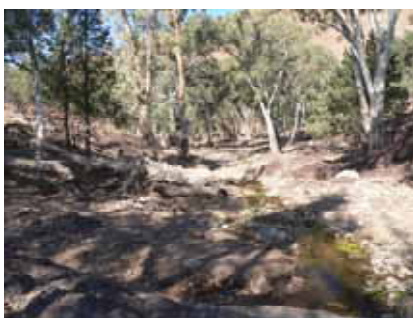
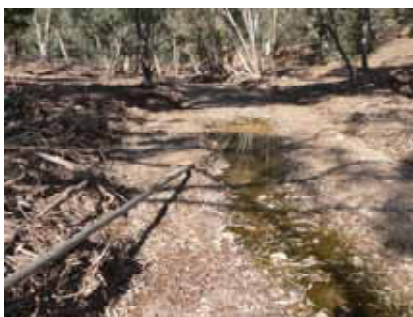
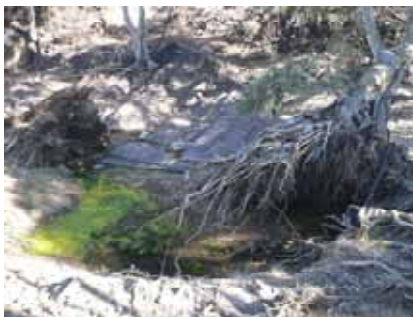
**Depth:** at time of visit, mostly shallow < 0.5m except for pool where water is piped to property 0.5 – 1.0 m deep.

These pools are part of the Pettana Spring system.  
Photos taken in October 2008 by Mel White.

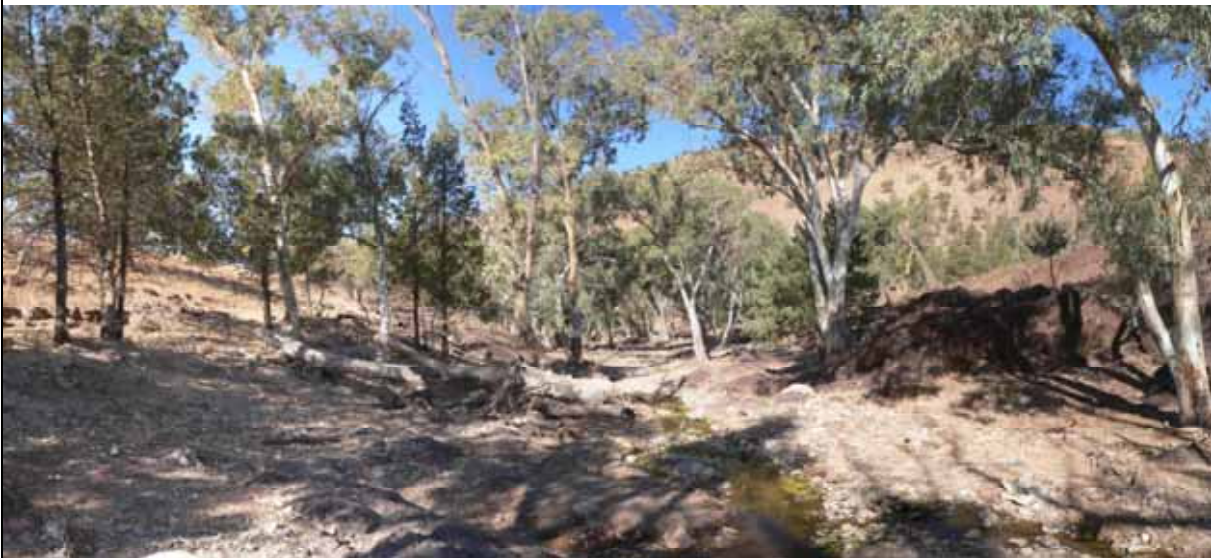
Photograph of riparian zone (red gum and native pine) of Pettana Spring in October 2008 (Mel White).

**MODERATE:** Based on the springs moderate restoration potential, its hydrological permanence in being a key aquatic refuge for the sub-catchment.
